The Regulatory Reform (Fire Safety) Order 2005 Type 4 Fire Risk Assessment Report at:

Clifford Court, Chorlton Road, Manchester, M15 4AZ

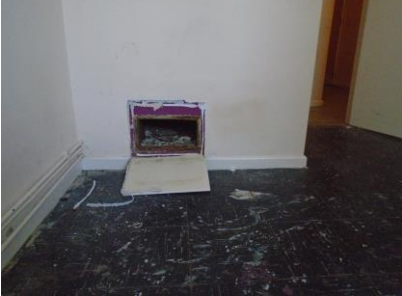
P1 – Plastic duct cover removed.	P2 – Plastic SVP

18.1	a	The new SVP is located to the right of the toilet and is enclosed in a 50mm x 25mm framed enclosure covered with thin plywood. The SVP was not collared, or fire stopped at the compartment floor or ceiling. A fire stopping solution should be developed and agreed to reduce the risk of fire spread.	B		
18.1	a	THT should also identify the flats where warm air heaters are still present and make arrangements for the removal of the appliances and boarding over of the common shaft with fire rated material.	C		
18.1	a	It is strongly recommended that a plan is developed to address compartmentation issues identified in flat units and further type 4 inspections take place in other flat layouts.	B

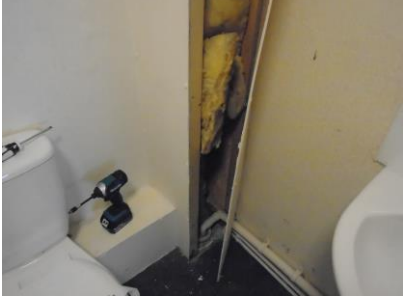
P3 – Cast Iron SVP	P4 – Rainwater pipe through balcony
