The Regulatory Reform (Fire Safety) Order 2005 Type 3 Fire Risk Assessment Report at:

Grafton Court, Chorlton Road, Manchester, M15 4AZ

REGULATORY REFORM (FIRE SAFETY) ORDER 2005 FIRE RISK ASSESSMENT

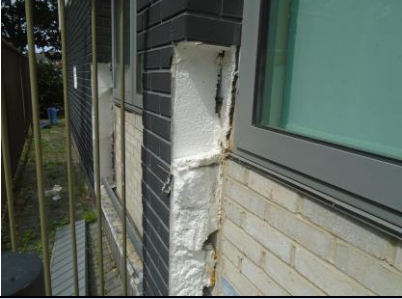
P1 – Exposed polystyrene.	P2 – Insulation surrounding gas main.

A photograph showing a corner of an exterior wall. The wall is covered in dark grey horizontal siding. A section of the wall is missing, revealing a thick layer of white polystyrene insulation. A window with a dark frame is visible to the right.

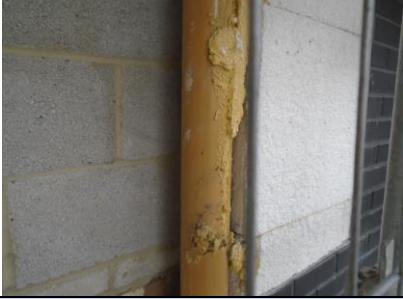
A close-up photograph of a vertical pipe, likely a gas main, surrounded by grey mineral wool insulation. The pipe is wrapped in a yellowish-brown material, possibly a vapor barrier or another layer of insulation. The background shows a brick wall.
P3 – Plastic SVP.	P4 – Wall bricked up.

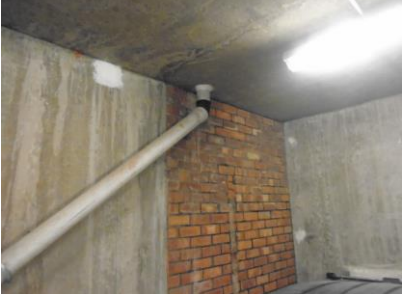
A photograph of an interior wall. The wall is covered in a white plastic vapor barrier (SVP). A white pipe runs horizontally across the wall. The ceiling is made of concrete and has a fluorescent light fixture.
